## Clifton Hill and Moa Bone Point

### Geotechnical - Rockfall Protection

Location: Clifton Hill Christchurch  
Date: April to September 2016  
Client: Fulton Hogan  
Principal: Christchurch City Council  
Consultant: Golder Associates, Christchurch

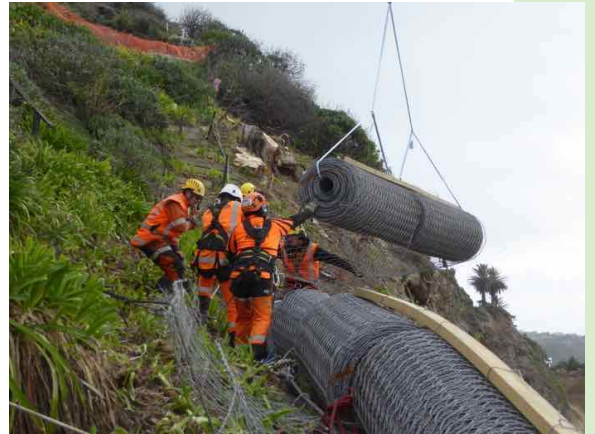
During the Christchurch Earthquakes in 2011, the cliffs at Clifton Hill & Moa Bone Point experienced significant ground shaking and as a result a large amount of material was lost due to cliff collapse & mass movement. As these sites are directly above the Sumner to Lyttelton Corridor, mitigating the rockfall risk to traffic along Main Road was essential.

Abseil Access were contracted by Fulton Hogan to carry out the cliff stabilisation works:

- Removing vegetation to gain access to the site & cliff face
- Light, moderate & heavy rock scaling with airbags & crow bars
- Removal of 24m<sup>3</sup> rock columns
- Supply & install 3400m<sup>2</sup> of draped Geofabrics PVC coated double twist rockfall netting
- Install face anchors at locations determined by the Engineer
- Installation of rock bolts to support potentially unstable blocks.

Working above a live road with traffic volumes of 20,000 vehicles per day the strict traffic management plan allowed for short duration 5-minute road closures. A helicopter was used to lift the 45 rolls of rockfall netting to the top edge of the cliff, which allowed the abseilers to position the netting directly on to the top cable - reducing the need for manual handling of the 170kg rolls. The netting was secured with a 19mm diameter galvanised wire cable.
