Reference Project

Geotechnical Slope Stabilisation

Location	Kaiwharawhara Switchyard, Wellington
Date	February 2020
Client	Transpower
Consultant	Downer

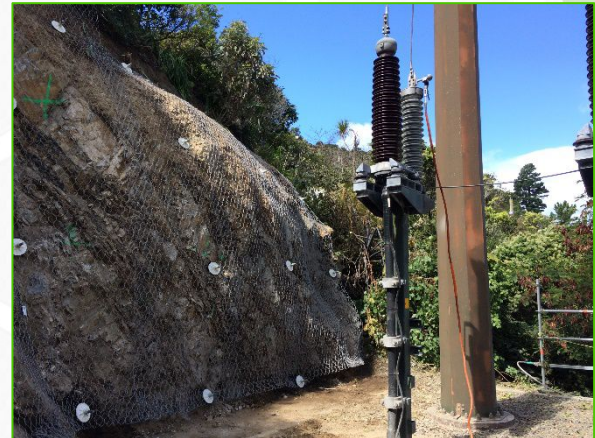
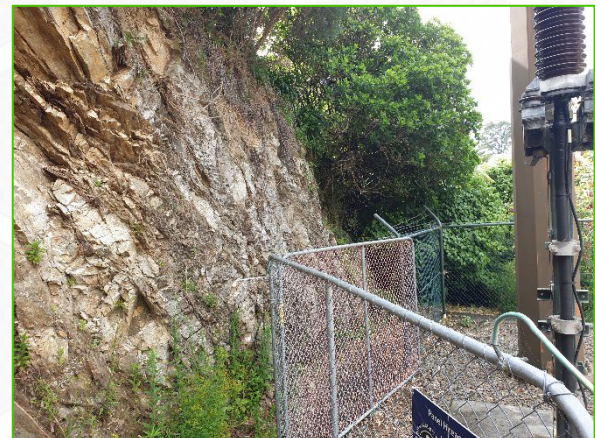
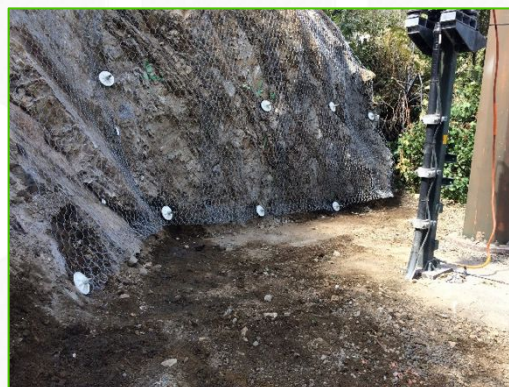
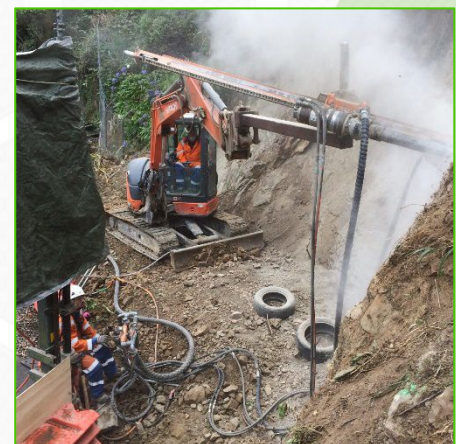
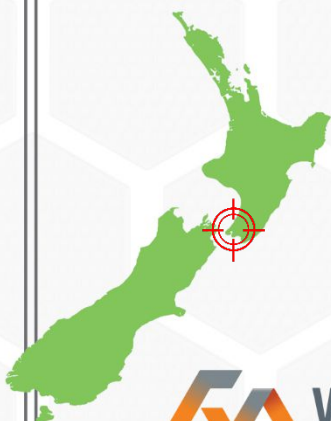
A recent rockfall had damaged the fence and further rockfall threatened the high voltage terminals. Abseil Access Geotechnical Division was engaged by Downer's Group to install ground anchors and mesh adjacent to critical switchyard appliances.

- Complying with Transpower switchyard safety procedures
- Shaping of the bank to improve the face profile.
- Drilling 100mm holes and installation of 25mm diameter glass reinforced plastic (GRP) anchors using a 5t digger as a drill vehicle.
- Installation of Geofabrics double twist PVC coated mesh.
- Developing an alternative methodology for the upper section when a suspected asbestos coated pipe was discovered in the area.

Abseil Access completed this scope within the allocated 2-week switchyard isolation period with no damage to the critical high voltage equipment. As result, Abseil Access have been requested to submit proposals to complete additional work which was outside of the original design.
