# ABSEIL ACCESS LTD

## Reference Project

### Inspection and Maintenance

Location: NZMP Hawera and other milk processing plants

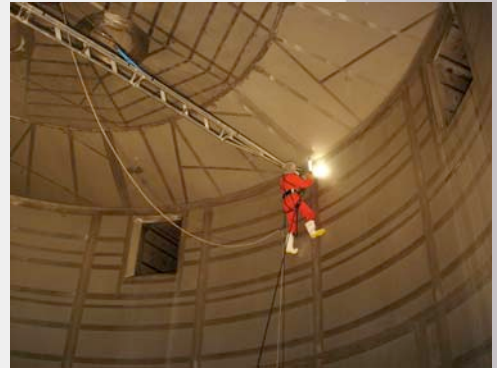
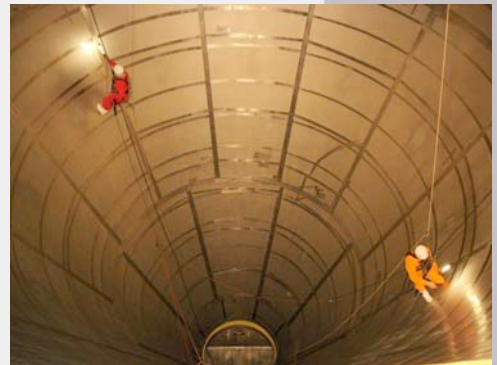
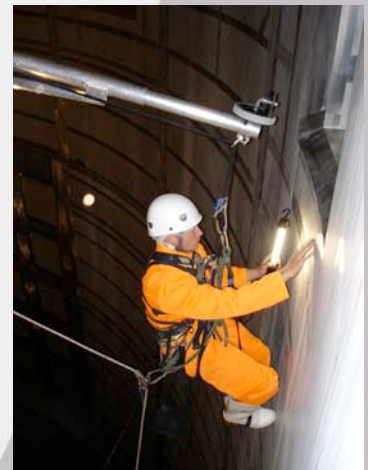
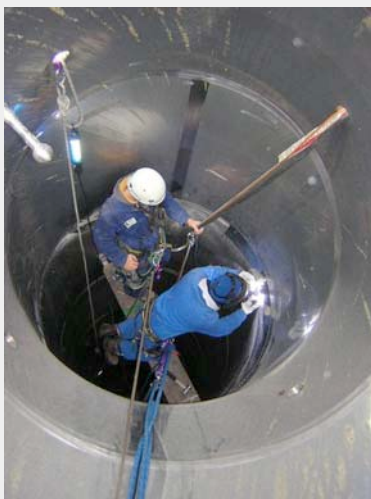
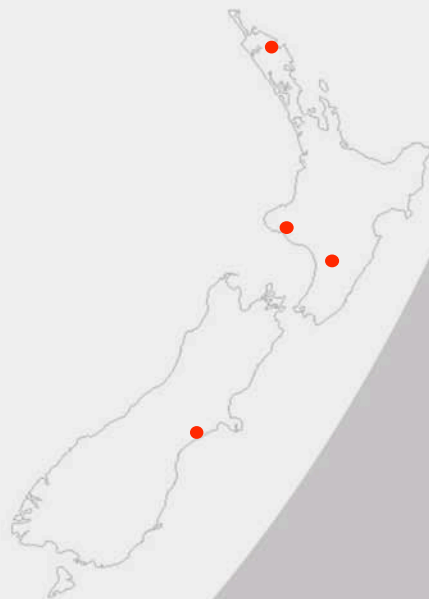
Some of the circular drier chambers are 15m in diameter. To achieve full coverage of the internal circumference Abseil Access Ltd have designed and built an aluminium telescopic modular truss boom which is suspended from a single mid point. Inspectors work in pairs and a systematic approach can be easily achieved.
